Maloperation Analysis and Preventive Measures of 500 kV Reactor Protection

Liuzhou Bureau, China Southern Power Grid EHV Power Transmission Company,
Liuzhou, 545006, China

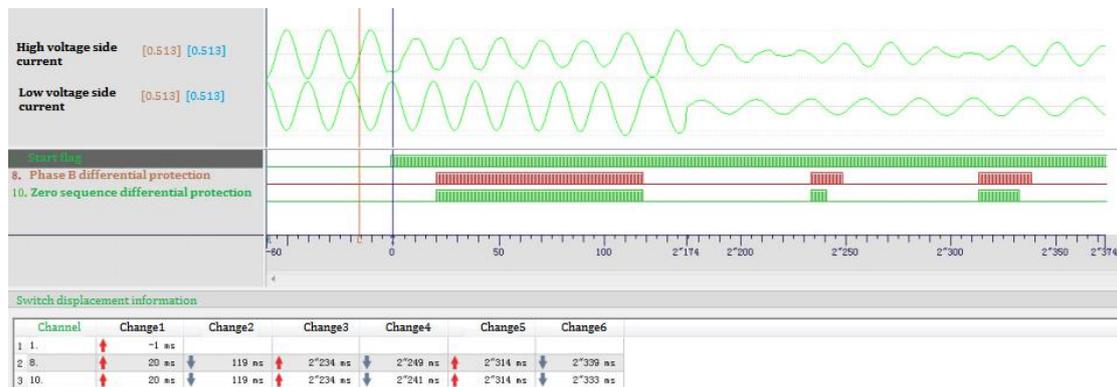
After the reactor was transformed into overhaul state, the maintainers checked out that the reactor body was without abnormality, and there was no gas in the gas relay; the three-phase reactor was tested by off-line oil chromatography and dielectric loss, and no abnormalities were found in the test results. The maintainers compared and analyzed the two sets of reactor protection wave shape and fault recording wave shape (the high-voltage sides of two sets of reactor protection casing pipes TA sampled from different windings), finding that the three-phase reactor voltage was three-phased balanced at about 61V before the circuit breaker tripped. The first set of TA current wave shape of reactor protection B-phase high-voltage side showed irregular changes, and the low-voltage side TA currents did not differ much. The B-phase current differential and the zero-sequence current differential returned in multiple actions, which lasted for 2 seconds. According to the wave recording figure, it can be initially seen that the secondary loop of the first set of reactor protection B-phase high-voltage side TA current is abnormal (As Figure 1).

Figure 1: The wave recording figure of the first set of reactor electric quantities

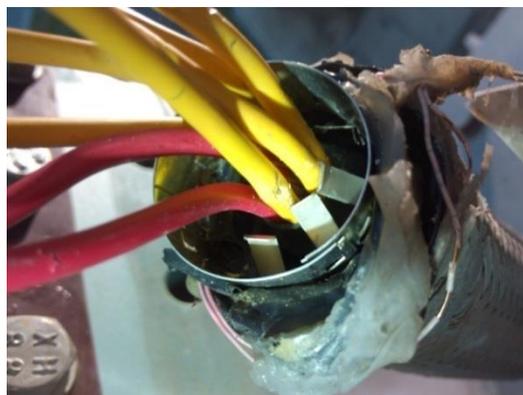
The maintainers inspected the first set of reactor secondary circuits. When the reactor is in the overhaul state, they found that the secondary current sampling values of the high voltage side of the A, B, and C phases of the first set of reactor protection device were 0A, 0.259 A, and 0A, and the secondary current sampling values of the low-voltage side were all 0A. They also found that the high-voltage side of the second set of reactor protection device and the secondary current sampling value of the low-voltage side were both 0A. The current secondary terminal was opened at the first reactor protection cubicle, and the sampling function of the first protection device was checked, which was normal. In the Phase B reactor body terminal box, the current clamp meter was used for the loop cable, and the display value was 0.254A. When we opened the current terminal connection piece, the current of the reactor terminal box to the protection cabinet was 0A, but when the current connection piece was closed, the current was 0.193A. When we short-circuited the current terminal, and measured the cable from the rising base to the body terminal box, the current increased to 0.345A, so we judged that the fault location was between the terminal box and the rising base. We open the secondary terminal box of bushing TA at high voltage side of phase B. During the opening process, it was found that the reactor first protection sampling abnormality was changing, while the second protection sampling did not change. After the cover was opened, the current disappeared to zero. The maintainers checked that the wiring of the terminal in the TA secondary terminal box is normal. After pulled out the cable, it was found that the iron piece of the fixed ferrule of the cable protection sleeve from the raised base of the high-voltage bushing to the terminal box of the body cuts into the cable core, which caused the insulation rubber of the cable core to be damaged (the broken cable was the first set of protection TA secondary cable) (As Figure 2).

Figure 2: The damaged part of cable insulation

The measurement value of the voltage of the cable sheathed tube to ground by a multimeter was 0.180V, and the measurement value of the secondary resistance of the current loop was about 1Ω. The

calculated induced current was about $0.180 \div 1 = 0.180$ A, which was close to the field current clamp test value of 0.176A.

In summary of the inspection and analysis, the reason for the misoperation of the first set of electrical quantity protection of 500kV reactor protection is that the design of the secondary cable ferrule of TA secondary terminal box of the high-voltage bushing of phase B reactor is unreasonable. As a result, the cable core of the first protective current circuit of phase B reactor at the secondary terminal box of high-voltage bushing TA constantly rubs against the ferrule under the action of vibration force, thus damaged the insulation of cable core. In this way, the induced current was connected to the current circuit of the first set of protection of B-phase reactor in series, resulting in abnormal current sampling, making the differential current and zero sequence current reach the action setting value, and then the protection acted.

4.1.3. When the manufacturer was wiring the main body cable, The cable head was not protruded into the terminal box, as a result, the fixed ferrule failed to press on the outer rubber of the cable and directly on the cable core.

Replace the cable with reactor to B-phase insulation and damage, and eliminate the metal ferrule, increase the protection of the PVC pipe to the lashing interface, block the terminal box, conduct the up-flow test on the body terminal box, and test the entire loop resistance. The coil windings are all above 100 MΩ.
