# Study of Failure Analysis of a Fracture Crankshaft Pulley Used on a Truck Engine

**Abstract.** A pulley is a mechanism consisting of a wheel, with a groove between its two edges, which is fastened to a shaft. The belt usually passes along the groove of the pulley to give it the power of movement and rotation. In December 2016 there was a case of failure of the crankshaft pulley in a truck. This study aims to investigate the causes of fracture. Therefore, it was necessary to perform a failure analysis. Investigation methods included visual examination, scanning electron microscope analysis, chemical analysis of the material and mechanical tests. A finite element analysis (FEA) was also performed to quantify the stress intensity factor ( $K_I$ ) distribution in the crankshaft pulley that is near the crack tip. From the finite element analysis, it was found that  $K_I$  was greater than the fracture toughness ( $K_{IC}$ ) of the material. Therefore, the propagation of crack occurs from the initial crack until final failure.

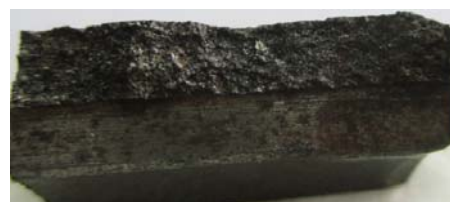
The visual observations of the failure in the crankshaft pulley in figure 2 show the initial location of the cracks, and cracks in the visible area of the keyway. Then, figure 3 shows the surface fractures that occurred when the cracks began to appear in the parts. In this case, the area of stress concentration in the pulley was at the keyway because this was the area with the smallest radius and sharp angles.

**Figure 3.** Fracture surface.

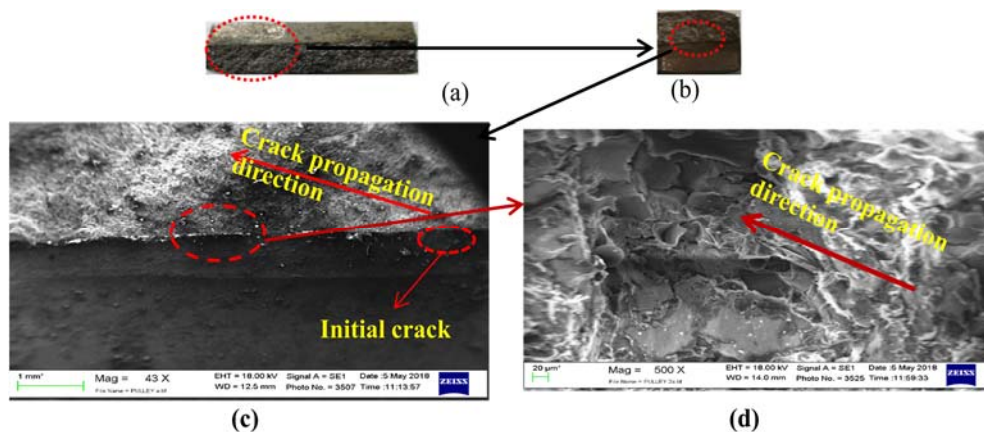
find out more about the pattern that occurred in the initial area of the fault, observations were made at a magnification of 41x. The results can be seen in figure 4 (c), which shows the initial cracks that occurred and the propagation of the cracks in two directions, namely, upwards and sideways. There were also chevron lines in the image.

**Figure 4.** (a) Cut Part of the Pulley for SEM observation. (b) Specimens for Fractographic testing. (c) Initial crack location. (d) Initial Cracks Performed 500X Magnification.

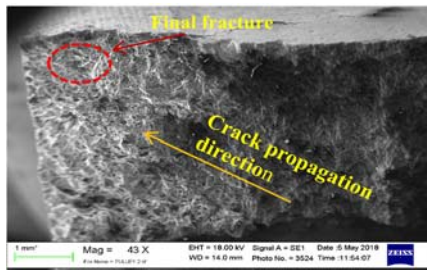
Then, the next area to be observed was at the tip of the fracture surface area. For these observations to be made, a magnification of 43x was sufficient as it was clear that there was a fracture surface pattern in this area, as shown in figure 5.

**Figure 5.** Fracture surface pattern.

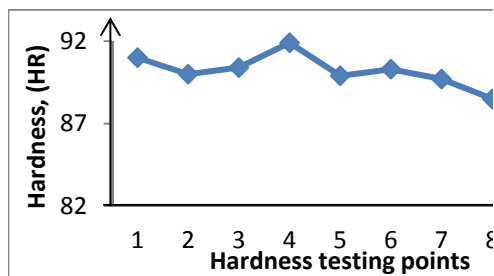
**Figure 7.** Hardness Testing Curve.

From the data obtained through the hardness test, as shown in figure 7 the average value of the hardness of the perpendicular cross-section was 88.6 HRB. The hardness of the inner area of the pulley was lower than that of the outer area of the pulley.

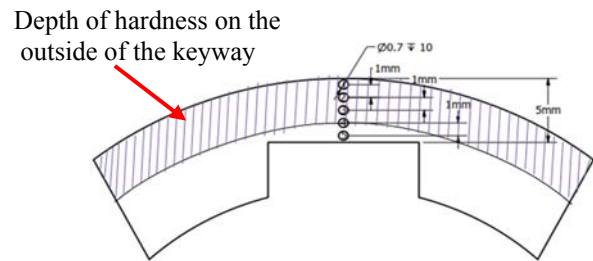
**Figure 8.** Sketch the hardness testing point around the keyway.

Figure 8 shows the keyway section, where the tightly-shaded part of the material with a thickness of 4 mm was harder than the part that was not shaded, while the remaining thickness of about 1 mm had a lower material strength than the shaded part, and it was this weaker part that caused the crack.

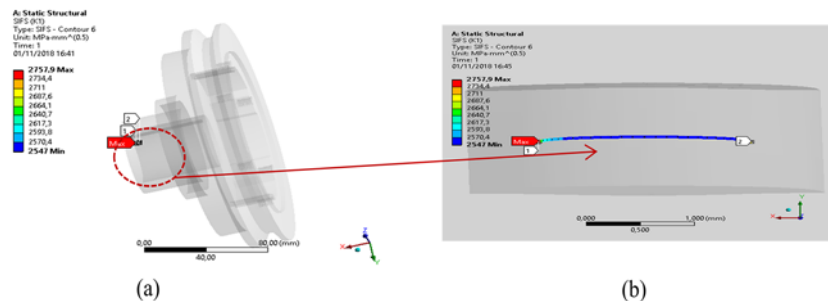
figure 9. A stress intensity factor ( $K_I$ ) of  $88 \text{ MPa}\cdot\text{m}^{1/2}$  was obtained from the simulation results larger than the fracture toughness ( $K_{IC}$ ) of the material was about  $41 \text{ MPa}\cdot\text{m}^{1/2}$  (as shown in table 2) . Therefore, this result indicated that crack propagation occurred on the crankshaft pulleys until final failure.

**Figure 10.** (a) Analysys of SIF ( $K_I$ ). (b) Magnification around crack tip.

According to the results, it can be concluded that the initial crack occurred because of the stress concentration in the sharp-angled keyway. Moreover, from the FEA results  $K_I$  that occurred near the crack tip was greater than the fracture toughness,  $K_{IC}$ . This also caused the crack propagation in the groove of the crankshaft pulley.
