Wear's issues on high-pressure common rail pumps

R C Iordache, N D Petrea and C Bujoreanu

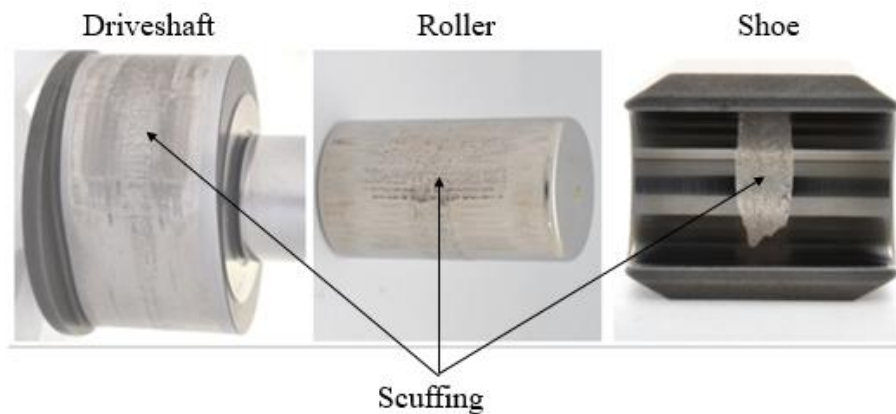
Transmission of motion into the high-pressure pumps is achieved via the drive-shaft. It is driven directly by the camshaft or crankshaft indirectly via transmission belts, chains or gears. This rotating motion of the drive shaft is transformed into a translation one. The cam comes into direct contact with the roller and makes possible this movement transformation. The lubrication is carried out with the fuel flowing through the pump. The drive shaft is made of high-strength steel. The roller is a rolling element with a logarithmic profile made of steel [3]. The shoe is made of a material that has excellent compatibility with the roller material. In order to have high wear resistance, it is covered with DLC (Diamond Like Carbon). Considering that these elements are in permanent contact and the fluid used for lubrication is a fuel with limited lubrication properties, the appearance of wear is inevitable. Working conditions, surface irregularities, components clearance, improper dimensions, load distribution, vibration, or surface condition facilitate wear appearance. The main types of wear in this mechanism are adhesion, DLC removal, abrasion and corrosion. The working parameters to which the pump is directly subjected can influence the fuel properties and the contact between the components. According to a previous study [4], a high-pressure pump was subjected to an aggravated test, the Low Sommerfeld Number. This type of experiment was performed under critical conditions of speed, temperature and pressure. It has been shown that these parameters adapted to aggravate the test correlated with low clearance between components lead to the occurrence of scuffing (figure 2). During the run, because of the critical conditions, the surface of the roller adheres to the surface of the shoe, which leads in blocking the pump components.

Figure 2. Roller, shoe and drive-shaft with scuffing after an aggressive test [4].

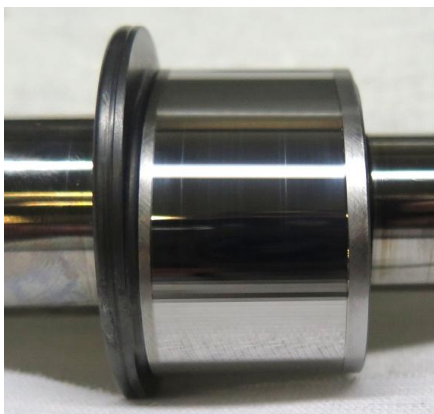
Mirror polishing (figure 3) is another important type of wear found in high pressure pumps and it appears on the drive shaft cam surface. This is not often seen because it is characterized as an effect due to the poor fuel properties. Over time, it leads to fatigue (figure 4).

Figure 3. Mirror polish.

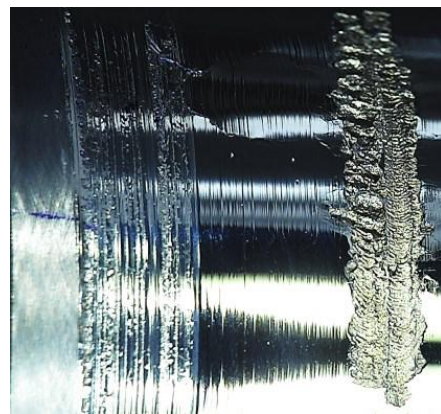
Figure 4. Fatigue on drive-shaft.

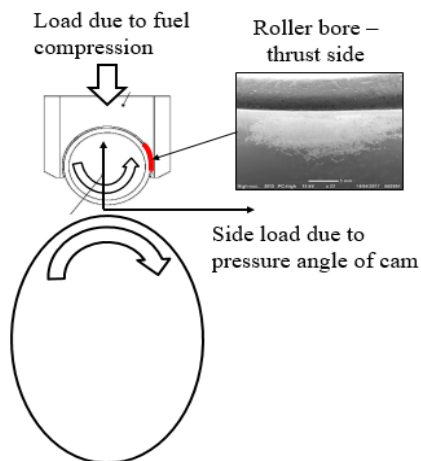
The shoe internal diameter area is the most sensitive for removal of DLC. Depending on the roller rotation direction, the pressure on the shoe edges is uneven (figure 5). Thus, DLC removal may occur (figure 6).

Figure 5. Shoe – load distribution.

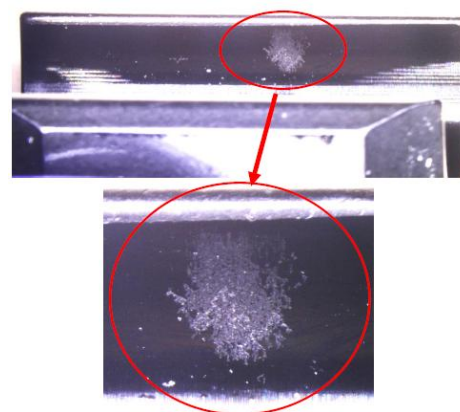
Figure 6. DLC Removal.

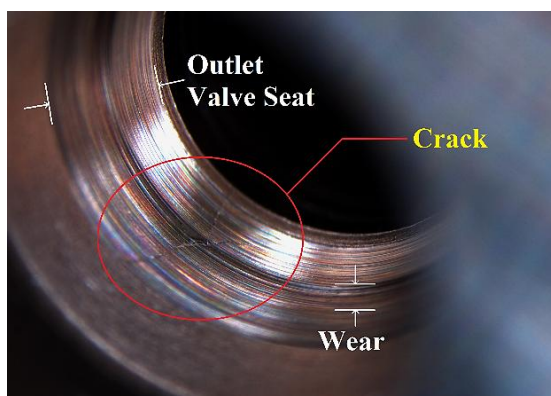
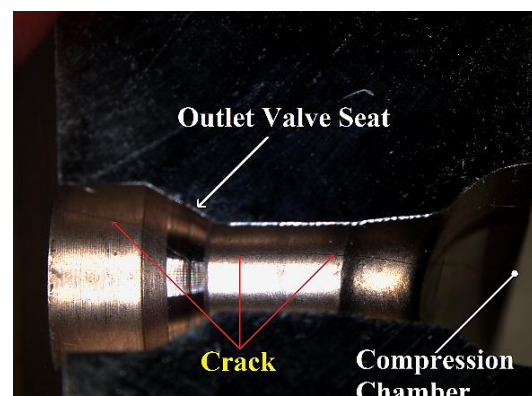
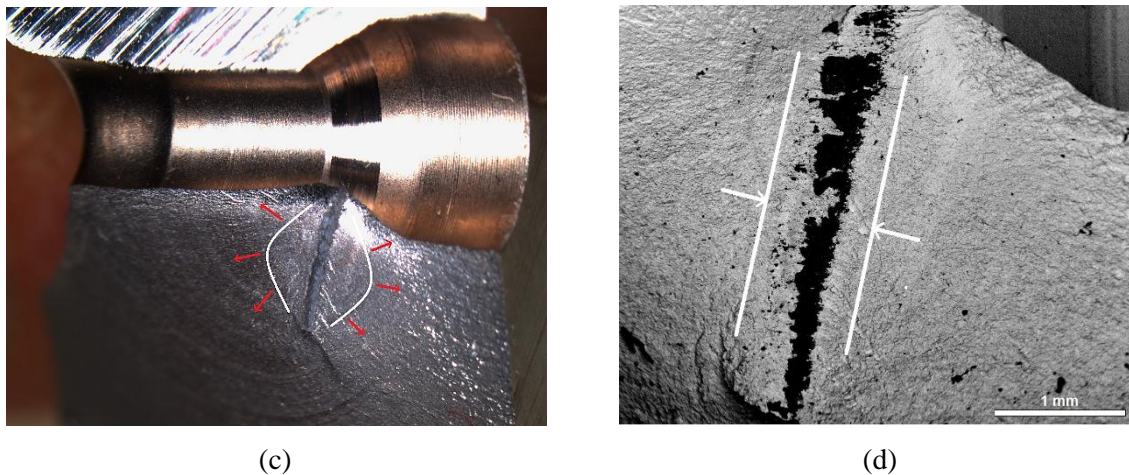
In figures 8 a, b (in a hydraulic head section) a crack on the outlet valve seat can be observed. During pump operation, this crack leads to high-pressure external leakage. By opening the fracture, the initiation point and the fracture pattern can be viewed in detail (figure 8 c). The crack initiation point is exactly on the machined spherical seat, in the worn area where the most considerable contact stress is due to the ball.

As a result of the analysis performed on the scanning electron microscope (SEM) in figure 8 d, an inclusion has been observed. It has a chemical composition different from that of the base steel which has an enormous influence on the mechanical properties of the material, mainly under high cyclic load conditions, resulting in a high dispersion of the fatigue life [7]. The main elements present in the inclusion are calcium (Ca), magnesium (Mg), aluminium (Al) and oxygen (O) and are suitable for a spinel inclusion, most likely formed during the steel manufacturing process.

Figure 8. Hydraulic head outlet valve failure due to material inclusion.

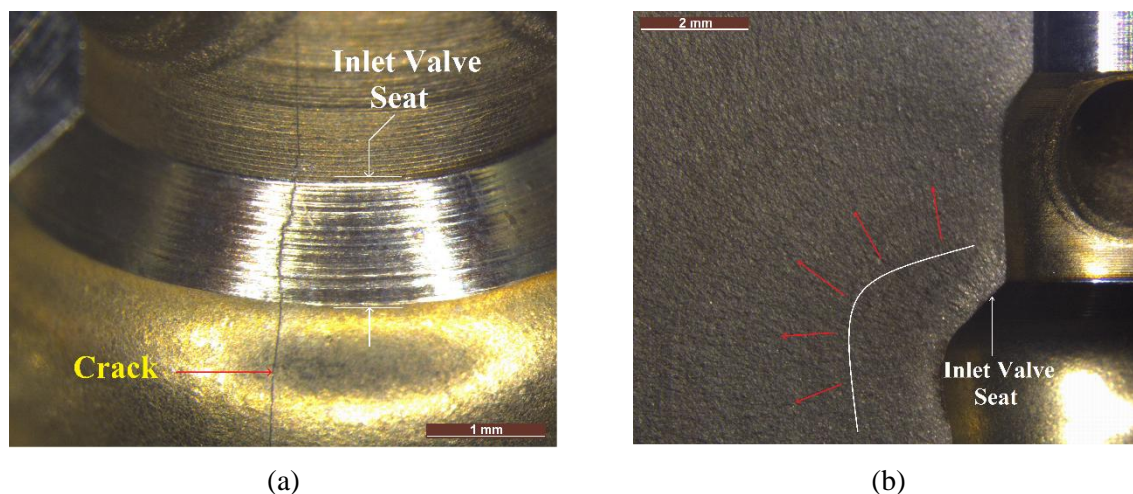
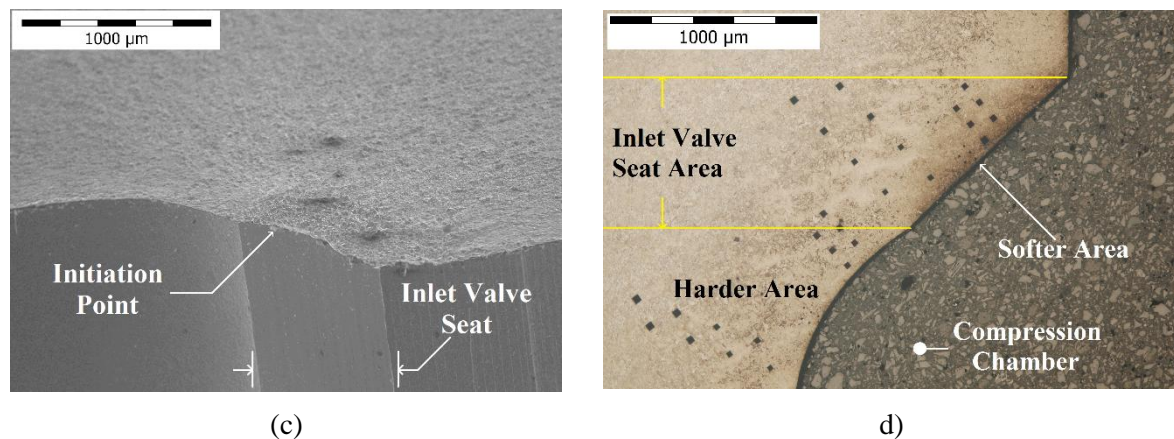
In figure 9 a, a crack on the inlet valve seat can be observed, which leads to external leakage during the pump compression stroke. The crack has been opened (one half in figure 9 b) and the fracture initiation point was identified on the inlet valve seat. At the scanning electron microscope, it was analyzed the fracture area in the region of the initiation point where a thin layer of material was observed (figure 9 c). This layer has a very fine fracture morphology indicating high hardness and high brittleness. Also, it has been found in the surrounding area signs of higher ductility due to over tempered martensite.

Half of the fracture was cut, polished and 2% Nital Etch Solution was used to reveal the microstructure (figure 9 d). A hardness check was performed, where the surface of the inlet valve, recognized on the image as a darker area, the material is much softer compared to other areas. The darker surface of the inlet valve seat is specific to the over tempered martensite which occurred during the machining process. The grinding process produces a very high temperature on the surface of the inlet valve seat in a short time that can change the metallurgical structure of the material and is called grinding burn [9, 10].

Figure 9. Hydraulic head failure due to inlet valve machining burn.
