Cause Analysis of Type IV Cracking of Main Steam Pipe of Ultra Supercritical Unit

Yao Xu¹, Shaohua Yin², Chunpo Tang¹ and Long Zhou¹

¹CHN Energy Taizhou Power Generation Co., Ltd.

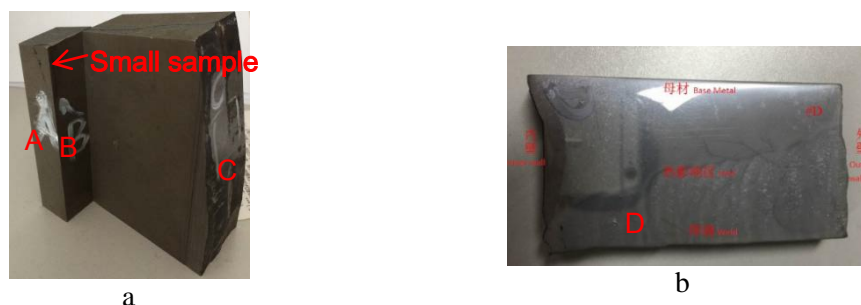
The metallographic sample is taken from the crack tip of the outer wall of the pipe and the entire pipe section. Cut the crack tip sample and observe the microstructure of the different sections of the sample. The different observation surfaces are numbered as #A, #B, #C, as shown in Figure 1a. The metallographic sample number of the pipe section is #D, as shown in Figure 1b.

Figure 1. Metallographic sample; a crack tip; b pipe cross section

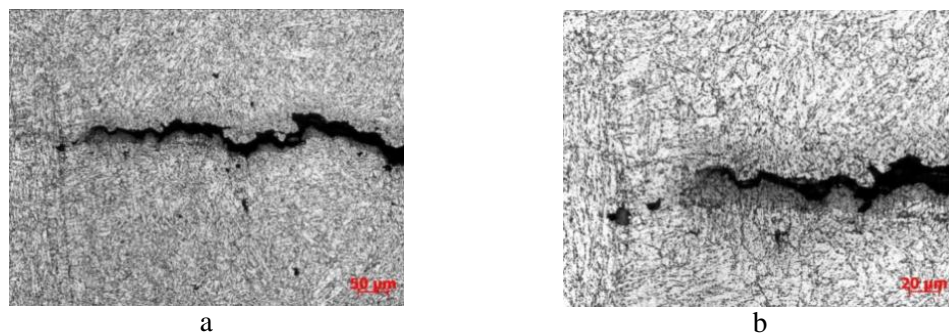
Figure 2. #C surface crack tip metallographic structure - a-200X,b-500X

From the metallographic photograph of the crack tip in Fig. 2, the position is organized as tempered lath martensite, micro-cavities exist around the main crack, and micro-holes are also formed in the front of the crack tip. The crack does not expand flatly, mainly along the crystal cracking characteristics. The crack occurrence region is the recrystallization region of the heat affected zone.

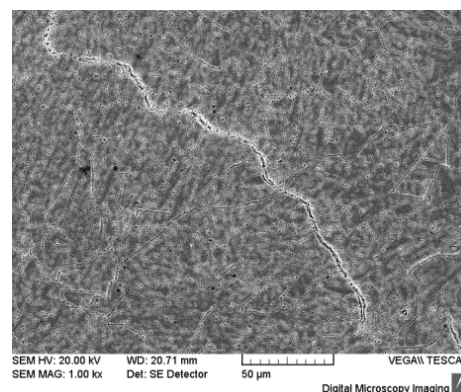
Figure 3. Scanning electron microscopy morphology of microcracks near the crack tip

In addition, during the observation of the crack tip microstructure, microcracks were found in the vicinity of the main crack, and microscopic cracks were observed by 1000X scanning electron microscopy are shown in Fig. 3.

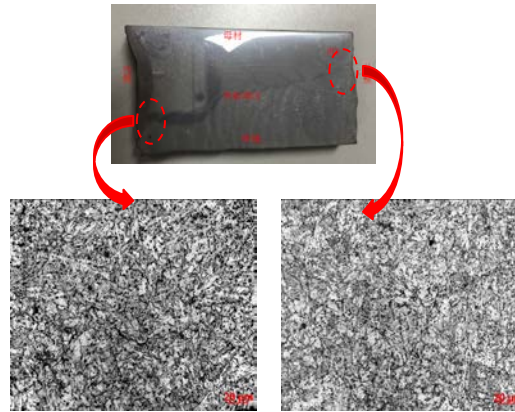
Figure 4. #D inner wall (left side), outer wall (right side) metallographic structure (500X)

It can be seen that the inner wall and the outer wall of the sample #D are organized into tempered lath martensite, and a small amount of creep pores exist in the structure, and the creep pores are distributed along the grain boundary.

Dispersed micro-creep holes appear in the fine-grained areas of the inner wall and outer wall heat-affected zone of sample #D. It shows that during the long-term operation of the pipeline under high temperature and low stress environment, creeping pores appear in P92 steel, and the overall performance deteriorates. In addition, during the operation of the unit, the vibration of the pipeline caused by the start and stop of the unit and the operation process may cause the support and hanger to be inclined, resulting in the outer wall of the pipeline being subjected to the bending and tensile stress load. The joint action of the two causes the crack to first open on the outer wall of the pipeline. crack. Therefore, the cracking failure is mainly caused by the bending load on the outer arc side of the pipeline, and the IV creep crack is the auxiliary interaction result.

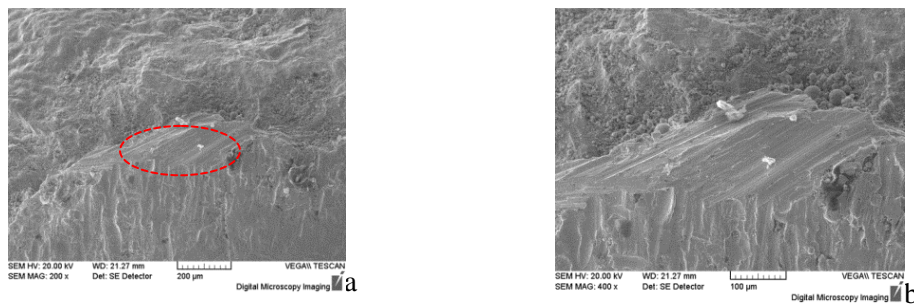
Figure 5. The outer wall crack fracture 3 o'clock-a-200X,b-400X

Looking at the scanning electron micrograph of Fig. 5, it is found that the fracture has been oxidized in a high temperature environment, and the thickness of the oxide film is thick, which masks the true shape of the fresh crack surface to some extent. In Fig. 5a, it can be seen that there is a similar river pattern through a large angle to reverse the grain boundary morphology (in the red circle), which is a distinct brittle transgranular fracture morphology^[4], and the crack cracking direction is extended from the bottom to the top, here It should be the crack initiation point. And the crack cracking direction is extended from the bottom to the top, where it should be the crack initiation. In addition, the high-magnification picture in Fig. 5b shows that the oxide film is mostly composed of oxide particles, and the fracture of the spherical particles is not flat expansion, which is characterized by the fracture along the crystal. Therefore, it can be shown that the crack is cracked by the outer wall in the long-term. During the operation, the crack gradually expands along the grain boundary and together, eventually forms a through crack.

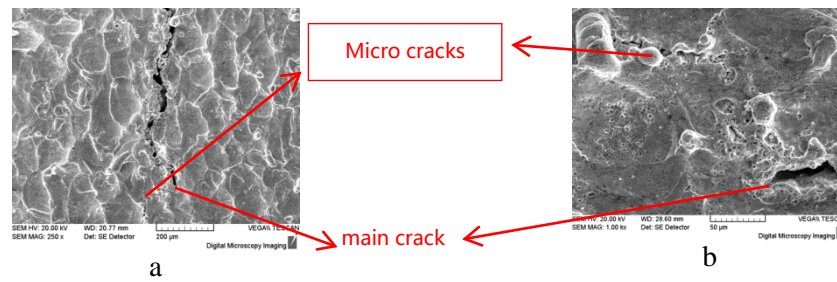
Figure 6. #B side crack tip scanning electron micrograph- a-250X, b-1000X

Observing the cracked tip of the #B sample, it is found that the main crack propagates along the grain boundary, there are new microcracks in the front of the crack tip, and there are many micro creep holes between the microcrack and the main crack tip, and the holes are connected. The tendency of microcracking, the morphology has obvious IV cracking characteristics.

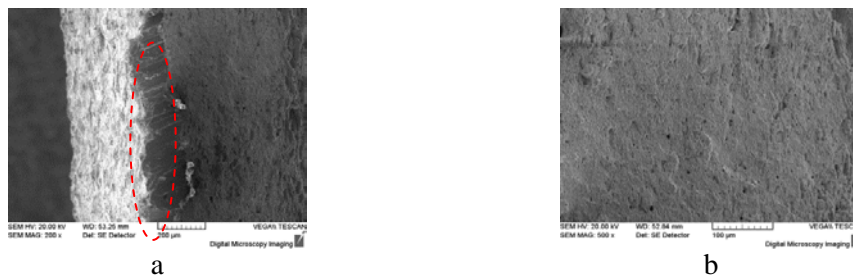
Figure 7. Scanning electron microscopy of fracture section of fractured specimen of curved specimen—a-200X, b-500X

Observing the fracture of the curved specimen, Figure 7a, it can be seen that the river pattern in this area also has a large angle to reverse the grain boundary morphology. The crack propagation direction is from left to right, and the middle intersection line is grain boundary. Due to the large twist angle, a large step is generated in the right crystal grain, so that the crack can continue to expand, which is obvious brittle cracking. The fracture morphology of the crack initiation zone is similar to that of the fracture zone of the outer wall of the pipeline, which indicates that the load subjected to the crack initiation failure is a bending load. Observe the fracture morphology of Figure 7b. There are more diffuse creep holes in the fracture zone, and the fracture surface is flush and brittle fracture.

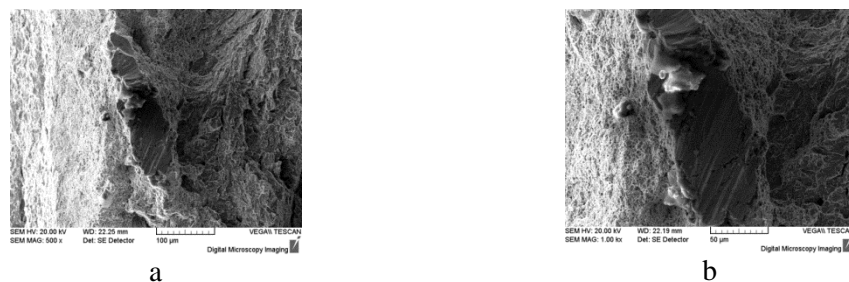
Figure 8. Scanning electron microscopic observation of the cracking zone of impact specimen ZCJ3—a-500X, b-1000X

Figure 8 is a scanning electron microscope observation of the cracking zone of the longitudinal impact specimen, in which the crack propagation direction is from left to right. The crack initiation zone begins with a small amount of dimple-like morphology, followed by a river pattern, and then a distinct cleavage fracture. This is consistent with a small impact test value. In addition, there are many micro-creep holes scattered in the cracking position, and no hole connection tendency is found. Combined with the impact fracture of the sample, it is found that the fracture has no obvious macroscopic plastic deformation, and the fracture is relatively flush, which is a distinct brittle fracture.

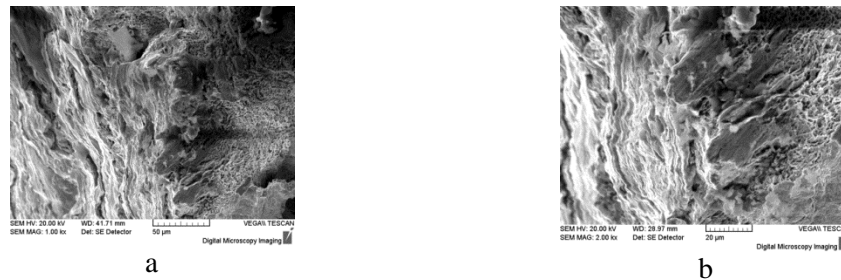
Figure 9. Room temperature tensile fracture scanning electron microscope - a-1000X, b-2000X

Figure 9 is a scanning electron microscope observation picture of the room temperature tensile test fracture. There are many dimples in the figure, and the tearing ridge is obvious. In combination with the macroscopic necking phenomenon, the fracture mode is ductile fracture.
