Fracture Analysis of the Chain Pin Shaft of an Escalator Ladder

Abstract. This study analyzed the cause of fracture for the chain pin shaft of an escalator ladder, and found that the pin material satisfied the chemical composition content requirements of the GB 20CrMo steel standard and similar to ASTM A29/A29M-2012 grade 4120. Abnormal metallurgical quality defects were not found in the pin. The pin shaft was carburized, and internal oxidation defects were not observed on the surface as a result of carburization. The internal structure of the material was uneven, there existed a mixed grain structure, and the martensite structure was coarse at particular regions, to seven grade. Additionally, the martensite structure in the carburized layer was slightly coarser, four to five grade, which had an adverse effect on the pin strength. The pin break was a fatigue fracture caused by multiple cumulative damages. The fracture originated on the surface of the pin, and may have been caused by indentation on the pin's surface.

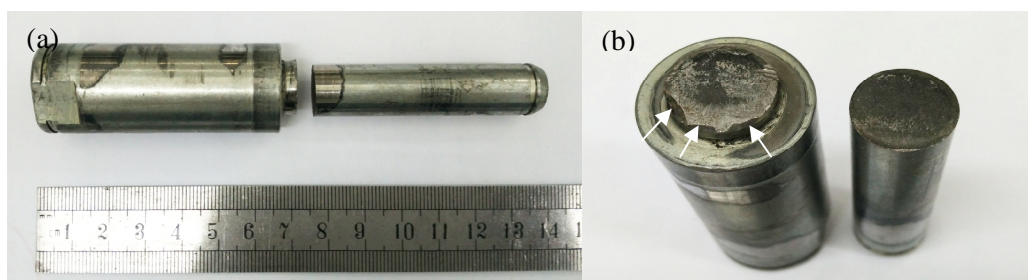
Escalator accidents occasionally occur; minor accidents cause property damage, while serious accidents result in human casualties. Determining the cause of such accidents is very important for avoiding escalator accidents. By investigating a particular escalator accident, it was found that the chain pin shaft had broken. The appearance of the broken pin shaft is shown in figure 1. As can be seen in the figure, the pin break occurred on a smooth surface at a distance of approximately 4 mm from the R position of the variable cross-sections. The fracture surface was relatively flat and approximately perpendicular to the axial direction. There existed significant bruising at the edge of the fracture near the end of the larger diameter, as indicated by the arrow in figure 1(b).

Figure 1. Appearance of stepped pin shaft fracture: (a) overall appearance of broken part of step chain pin; (b) macroscopic morphology of uncleaned fracture.

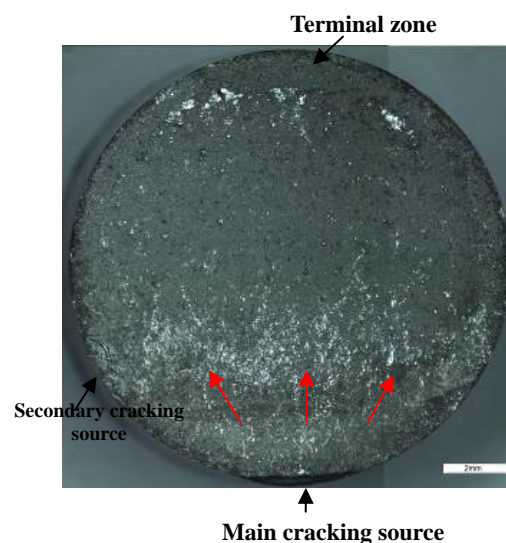
The macroscopic morphology of the broken shaft fracture after cleaning is shown in figure 2, the main cracking source of the broken shaft was located on the surface of the shaft, and a secondary cracking source was observed near the shaft surface in the fracture. The expansion direction of the main crack is indicated by the red arrows in the figures. Moreover, there existed a faint beach-like pattern on the fracture, which indicated that the pin fracture may have been fatigue fracture.

Figure 2. Low optical magnification fracture image of broken shaft fracture after cleaning.

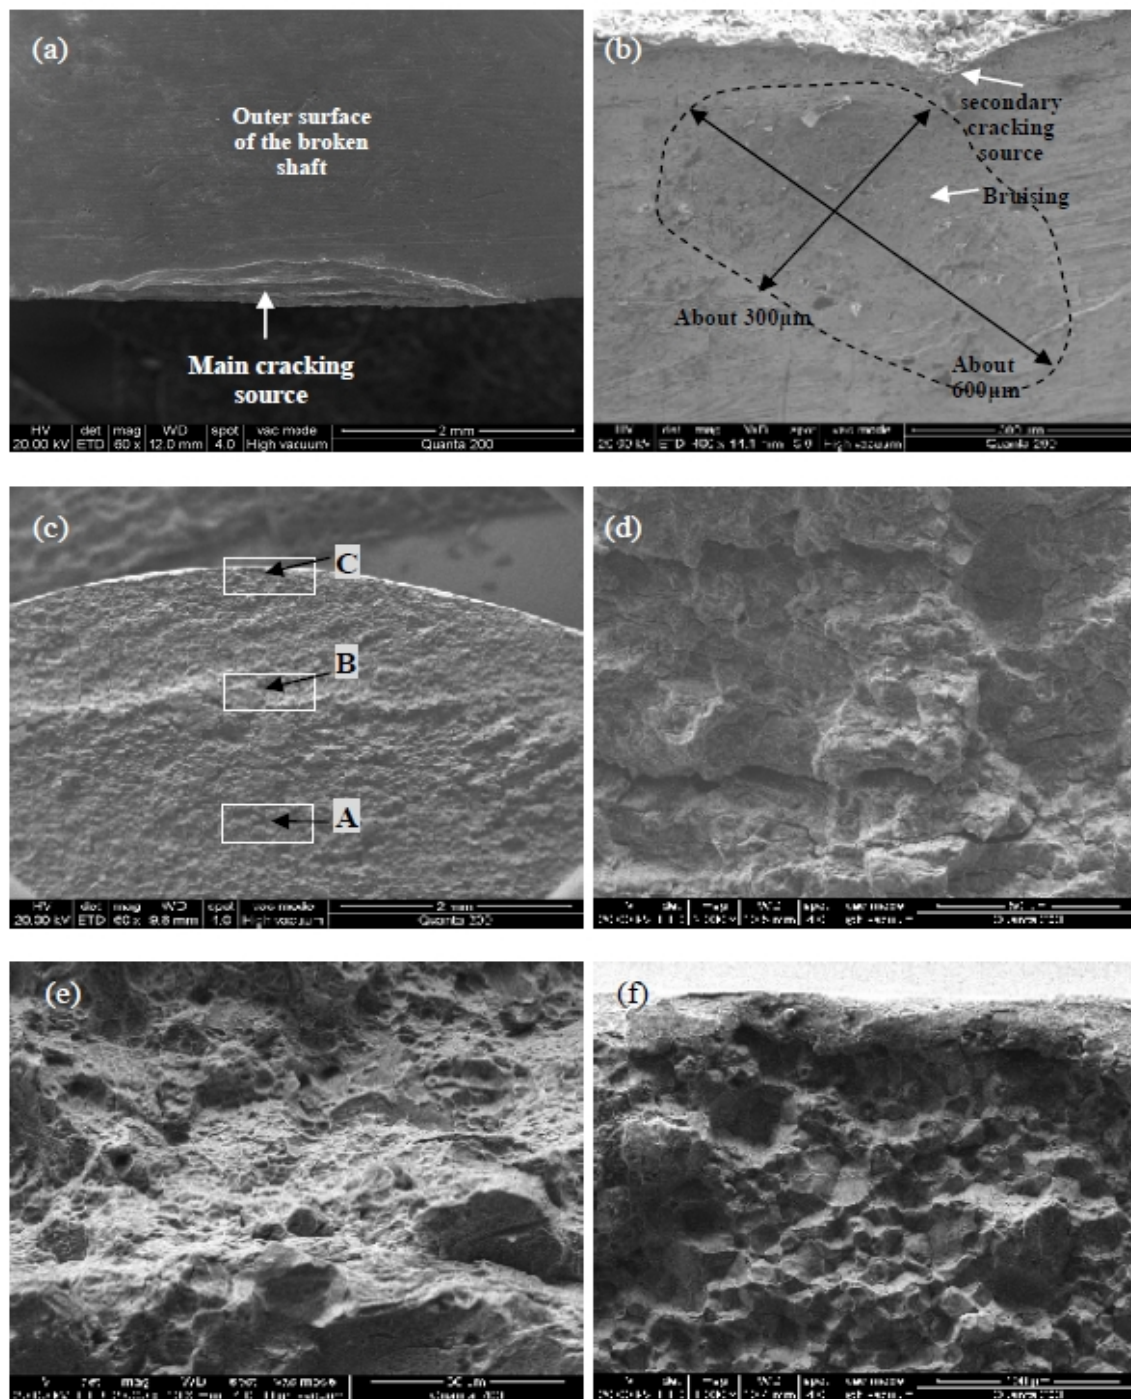
The microtopography of the broken shaft fracture is shown in figure 3-1(a)-(b), there is a trace of collision in the main cracking source, which may have been formed after the pin broke. Therefore, it is impossible to confirm whether the cracking source cracked owing to metallurgical quality defects or processing defects. This fracture near the surface of the shaft was mainly intergranular brittle fracture, which indicates that the material of the shaft surface was brittle.

Figure 3-1. Microscopic morphology of broken shaft fracture. (a) Main crack source area shown in figure 2; (b) Outer surface close to secondary crack source; (c) Near termination zone shown in figure 2; (d) Area A in (c) (fatigue striation); (e) Area B in (c) (dimple); (f) Area C in (c) (brittle intercrystalline fracture in rock candy form).

In figure 3-1(c)-(d), in addition to the main cracking source, a secondary cracking source can be observed in the vicinity of the main cracking source. Abnormal metallurgical quality defects were not observed in the secondary cracking source region of the fracture, but a bruise mark was observed on the pin surface near the secondary cracking source region. The size of the crushed part was approximately $600 \times 300 \mu\text{m}$. Considering the small probability of only forming such a small crush at

the secondary cracking source after the pin broke, it is believed that the crush mark formed before the fracture and caused the creation of the cracking source.

In figure 3-1(e)-(f), there existed a fatigue striation on the fracture, which indicated fatigue fracture. Thus, the fracture of the pin was actually fatigue fracture in the termination zone belonging to the instantaneous fracture zone, and the microscopic features of the fracture near the core were mainly dimples. Additionally, the microscopic features of the fracture near the surface area mainly indicated a brittle intercrystalline fracture in the form of rock candy. This indicates that the pin was subjected to surface strengthening treatment, and thus the core material had good toughness.

In summary, the pin fracture was fatigue fracture, but the main fatigue source was damage by crushing after the pin broke. Therefore, it was impossible to confirm the crack source defect that caused the pin to undergo fatigue fracture by the secondary crack source; namely, the pin surface pressure injury defects. Hence, it was assumed that the main cracking source may also had similar crushing defects resulting in fatigue cracking.

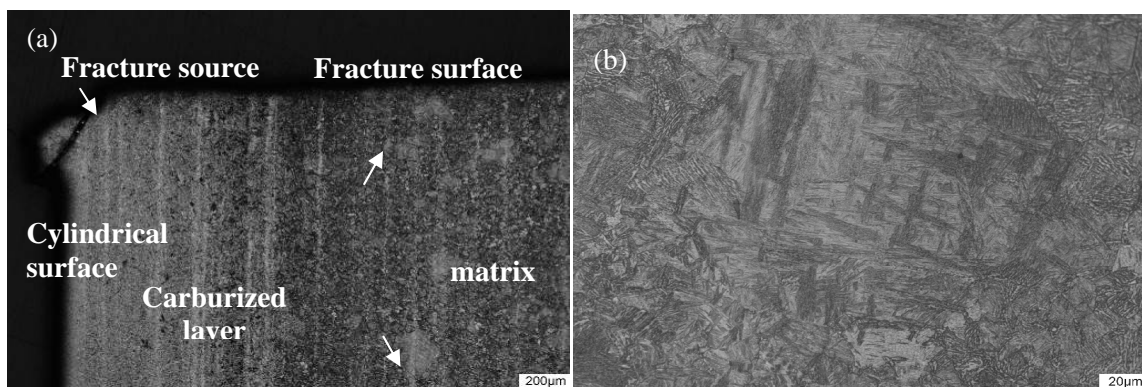
The microstructure of the axial surface of the axial specimen after etching is shown in figure 3-2, the microstructure image of the radial surface after etching the specimen is shown in figure 3-3. The microstructure of the material indicates that the surface of the broken shaft was carburized. The tempered martensite structure of the carburized layer was slightly coarser, four to five grade, which led to an increase in the brittleness of the shaft surface material. Moreover, the grain of the pin matrix material was uneven, and there existed an abnormally coarse tempered martensite microstructure in particular regions. The hardness of the coarse grain zone determined using the Micro Vickers hardness method was 430-460 HV, and the hardness of the fine grain zone was 360-380 HV. The mixed grain microstructure had a negative effect on the strength of the material[1, 2, 3, 4]. Because the sample to be inspected was very small, tensile testing and impact testing could not be performed.

Figure 3-2. Microstructural morphology of axial matrix specimen near outer surface in cracking source area: (a) Low-magnification morphology (arrow on matrix indicates coarse martensite area); (b) High-magnification morphology of coarse-grained matrix region, light block area in (a).

According to the Chinese machinery industry standard “JB/T 9211-2008 Martensite grade medium-carbon steel medium-carbon alloy structural steel”, the tempered martensite structure grade to base in the coarse grain zone was assessed as 7 grade, and the tempered martensite grade in the fine grain zone was 4 grade. A mixed grain structure appeared inside the material, maybe owing to the abnormal growth of local grain resulting from the short duration of over-temperature during the heat

treatment of the material. Alternatively, it may have occurred owing to improper forging also, such as the forging ratio may have been insufficient, or the final forging temperature may have been too high, or uneven temperature, thus resulting in an uneven material structure and partial coarse grain regions[5,6,7]. Additionally, the mixed grain structure was more likely to occur under normal heat treatment conditions; grain refining by micro-alloying was effective in suppressing the formation of mixed grain[8].

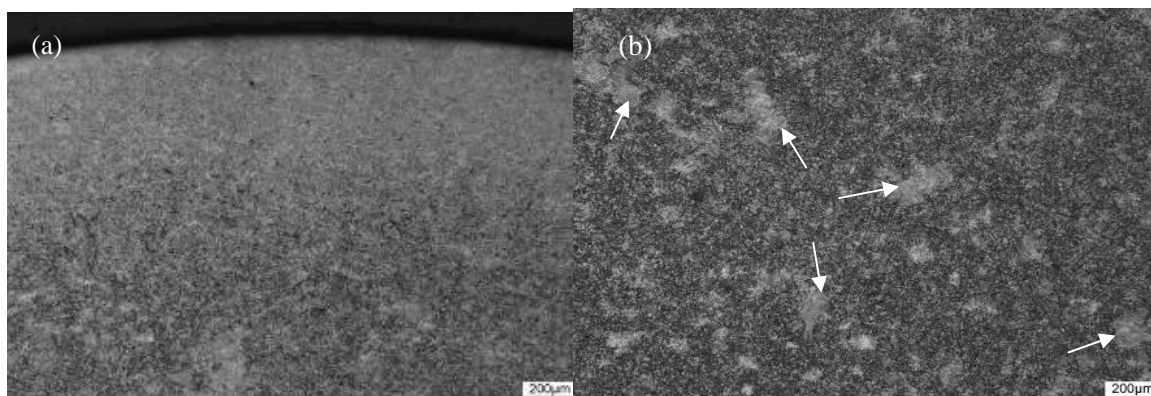
Figure 3-3. Microstructural morphology of radial matrix specimen: (a) near surface; (b) close to core (arrow indicates coarse martensite area).

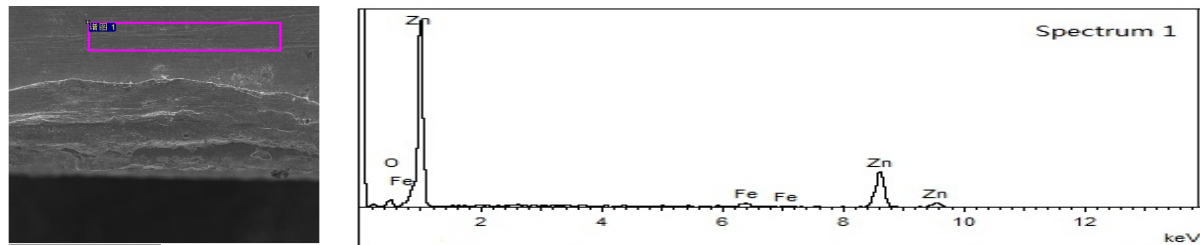
Energy spectrum analysis confirmed that there existed a coating with a thickness of approximately 1 μm as a galvanized layer on the shaft surface (figure 3-4). From the appearance of the coating distribution in the fracture source region and the deformation of the structure, it was assessed that the region formed by collision after the pin broke.

Figure 3-4. Energy spectrum analysis results for coating on pin surface.

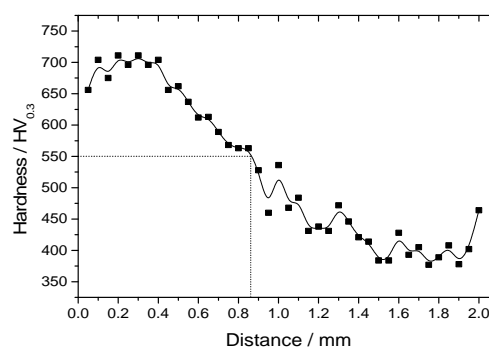
Figure 4. Hardness distribution curve of hardened layer on broken shaft.

The surface hardness change of the broken shaft conforms to the general rule of hardness change after carburizing treatment, as can be seen, the effectively hardened layer depth of the broken shaft was approximately 0.86 mm, according to ISO 2639-2002. And the hardness of the matrix fluctuates greatly, further indicating that the microstructure of the matrix is uneven.
