# Indoor temperature monitoring for cultural heritage

**Abstract.** The preservation of cultural heritage is one of the most important tasks in considering heat and humidity mode of museum premises, which should be as stable as possible. The choice of exhibiting place can significantly affect the safety of museum collections. The formation of temperature gradient on the picture's surface can cause breaks and cracks of colorful layer and substrate (canvas, paper, wood). Moisture, penetrating in gaps of colorful layer of painting, accelerates the aging processes. Increasing relative humidity and indoor air temperature can cause mold growing in glue layer. To reduce risk of thermal stresses throughout a year, it is necessary to provide thermographic measurements of building envelope and exhibit places.

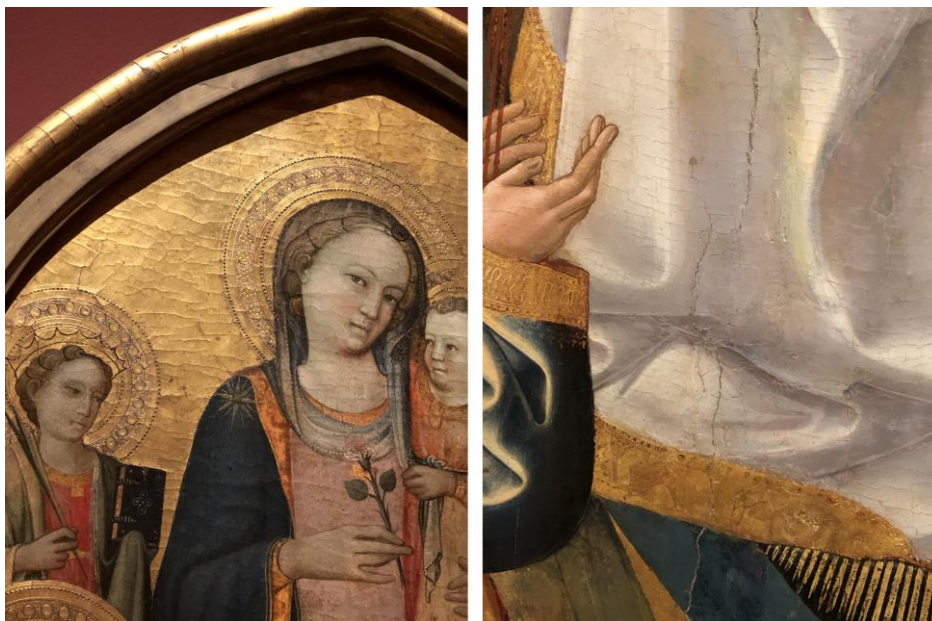
**Figure 1.** Breaks in the paint layers and primers as a result of the exhibit aging under the influence of temperature and humidity fluctuations.

However, the analysis of indoor microclimate quality using the average air temperature is a rough estimate of the storage conditions. Air temperature and relative humidity can vary considerably not only within one room, but also within one exhibit. The presence of a temperature gradient on the painting's surface contributes to the destruction of colorful layer and substrate (canvas, paper, wood). Paintings are created from various materials, with different temperature expansion coefficients. Uneven temperature field leads to the appearance of temperature stresses, different equilibrium moisture content in various areas, which leads to stratification and ruptures of paint layers and primers - Figure 1 [2, 3].

When the temperature increases, the elasticity of the paint layer gets lost and it becomes more rigid [8]. The expansion and contraction of the substrate and primer will have a significant impact on it. Cracks and gaps appear on the painting's surface (Figure 1, left photo). If the connection between the paint layer and the primer is poor, the painting is dissecting and warping.

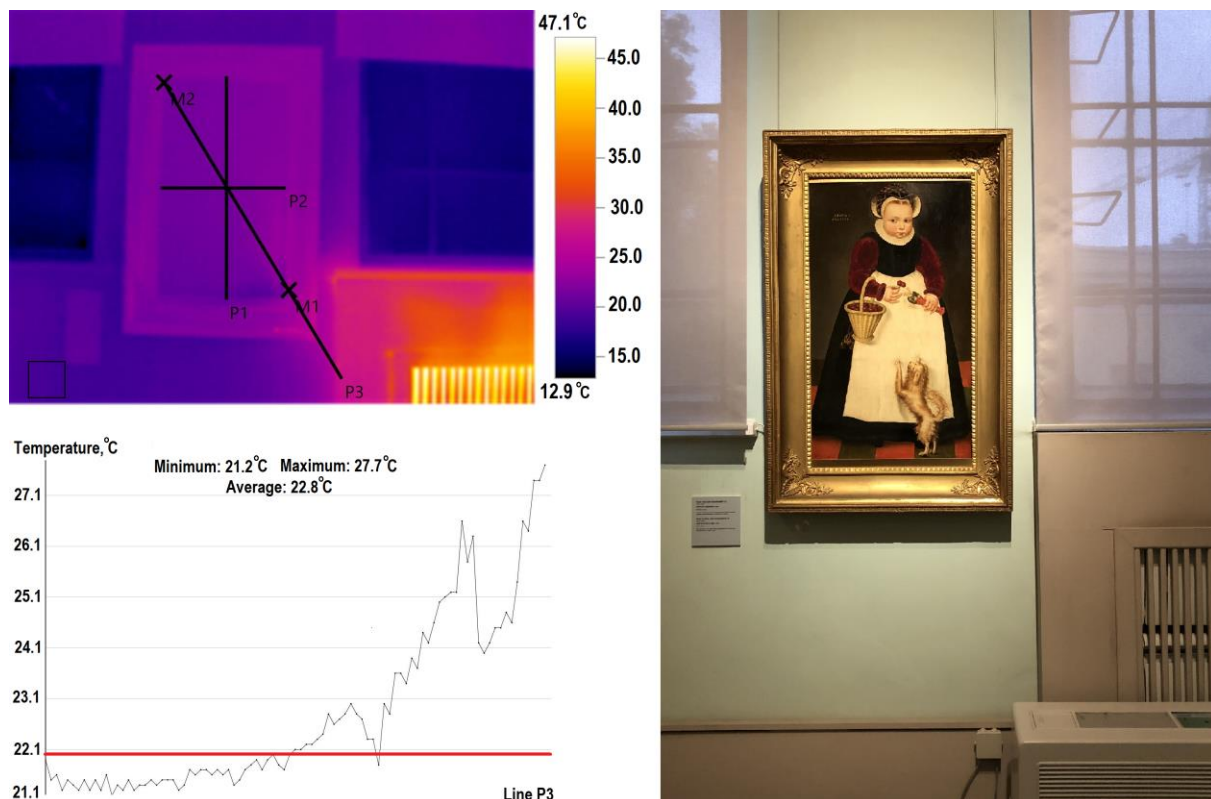
**Figure 2.** The results of experimental studies (exhibition hall 1). Left top picture – thermographic image; bottom left picture – temperature curve (line P3); right picture – photo of exhibit.

Vertical temperature gradient (line P1 – Figure 2) is 1.9 °C, horizontal temperature gradient (line P2 – Figure 2) is 1.6 °C. The lower left corner of the painting located in the zone of high temperature arising under the influence of convective free flows near the hot surface of heating device. Temperature in point M1 is 23.6 °C and 21.9 °C in point M2.

In the case study building all paintings have an air gap between the interior surface of external wall and canvas. It is a very important factor, because it can provide the zone with a particular air velocity in it. Such ventilated area helps to avoid condensation behind the painting. Analysis of experimental studies was made in two steps: identification of the location of heated and cooled surfaces and determination of the temperature gradients on the picture surface. The Figure 2 shows the results of measurements.

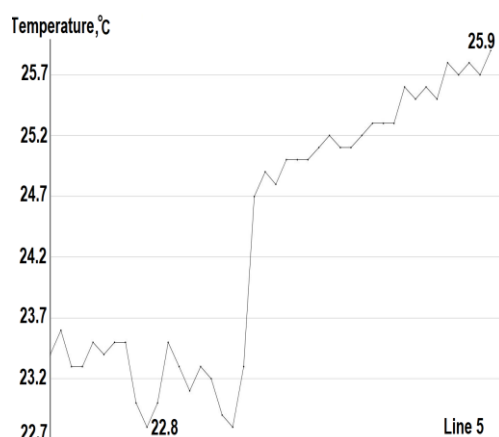
**Figure 4.** Temperature curve (line 5)

Figure 4 shows the position of the highest (HS1) and lowest (CS1) temperature points. M1 – point on the oil painting surface. Thermographic measurements allow identifying condensation zones. For this purpose, the dew point temperature should be found in each room, which is the most important factor determining the stability of internal microclimate parameters. As the number of visitors increases (which is especially noticeable during temporary exhibitions), the relative humidity and indoor air temperature can increase, which will lead to an increase of dew point temperature. That means that condensation on the building envelope can begin at a higher surface temperature.

The temperature change from the center of the painting to the hottest point is shown in the Figure 4.

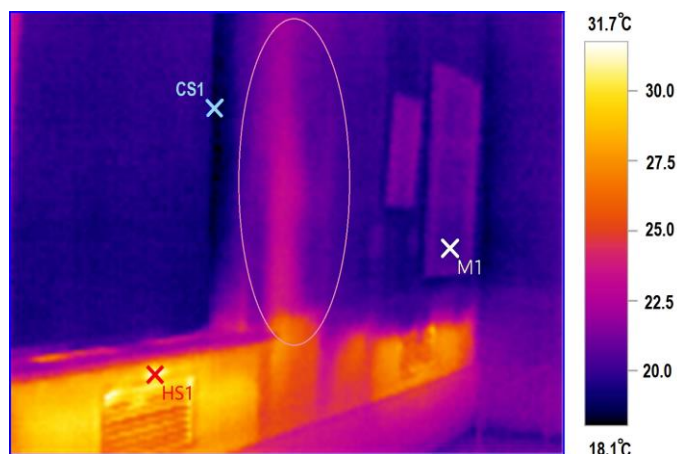
**Figure 5.** Thermographic image of exhibition hall 2.

In the exhibition hall 2, both paintings are located in the zone of high temperatures (Figure 3). The main reason of this phenomenon is hidden vertical pipes of water heating system, which are clearly shown in the Figure 5. Vertical temperature gradients on the picture surfaces are 1 °C (line P1) and 0.6 °C (line P3). Horizontal temperature gradients on the pictures are 1.1 °C (line P2) and 0.7 °C (line P4). However, minimal temperature on the surface is higher than required values in both cases (Table 1).
