The performance of composite steel in the elements of a post-fire steel bridge

Abstract. The steel structure is commonly acknowledged able to return to its original strength condition. It is yet unknown whether composite structure may return to its initial condition. Test specimen on the present study consists of 8 units, each of them divided into four stud-connector bold (SP) composites beams and four UNP connector (SF) composite beams. Each of the specimen has control value by SP/020 and SF/020, and other six specimens with combustion of SP/400, SP/550, SP/700 and SF/400, SF/500, SF/700, within condition of point load for about 12 kN. The study intends to investigate composite girder of post-fire bridge element towards duration and heat temperature factors and effect of beam performance towards stud-connector and UNP connector composites. The results draw several conclusions; The process of composite combustion shows that the failure on composite steel beam specimen is due to the load, burning duration and temperature which results in residual deflection. Deflection test reveals the effect of temperature, load, and duration do not give significant impact to load capacity of post

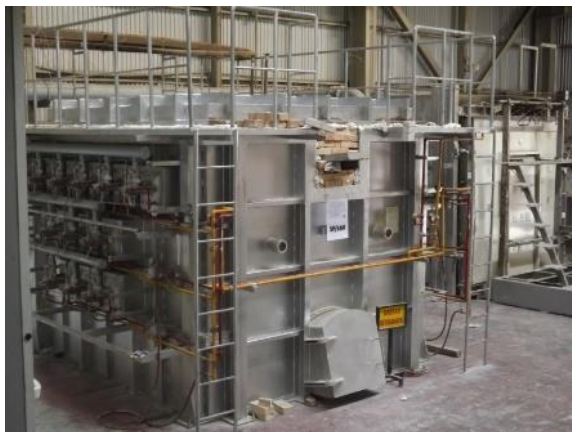
Fire test used by ASTM E119 Standard Methods of Fire Test of Building Construction and Materials [5]. Fire test was performed in Building Science Laboratory of Research and Development Center at Ministry of Public Work and Housing Residential, by using the fire furnace as it can be seen in figure 3 and 4 below.

Figure 3. Fire furnace.

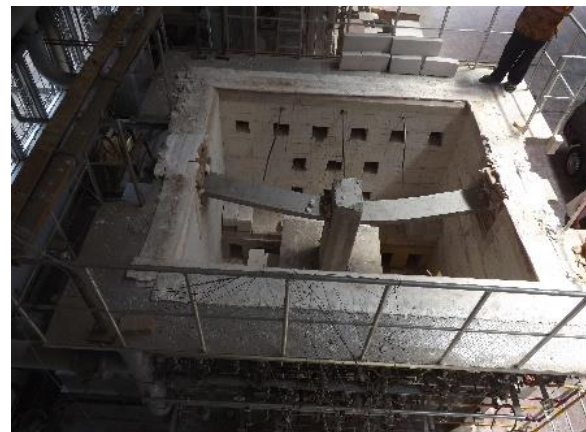
Figure 4. Specimen incineration/burning.

During the burning process, an observation is executed within 5 minutes' interval then measures the deflection of load and furnace temperature until the result is obtained. This process will unveil the relation between deformation and burning temperature. Thus, the decline of composite beam and its relation to reduction of steel and concrete elasticity modulus can be revealed.
