# Study of Failure Analysis of a Fracture Crankshaft Pulley Used on a Truck Engine

**Abstract.** A pulley is a mechanism consisting of a wheel, with a groove between its two edges, which is fastened to a shaft. The belt usually passes along the groove of the pulley to give it the power of movement and rotation. In December 2016 there was a case of failure of the crankshaft pulley in a truck. This study aims to investigate the causes of fracture. Therefore, it was necessary to perform a failure analysis. Investigation methods included visual examination, scanning electron microscope analysis, chemical analysis of the material and mechanical tests. A finite element analysis (FEA) was also performed to quantify the stress intensity factor ( $K_I$ ) distribution in the crankshaft pulley that is near the crack tip. From the finite element analysis, it was found that  $K_I$  was greater than the fracture toughness ( $K_{IC}$ ) of the material. Therefore, the propagation of crack occurs from the initial crack until final failure.

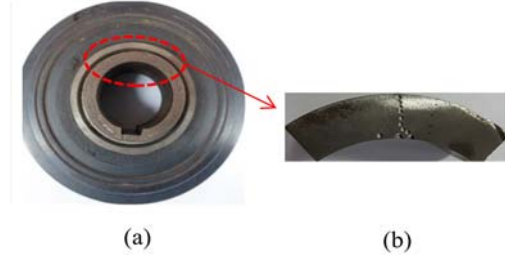
**Figure 6.** a) Parts of Pulleys Cut for hardness testing. b) Hardness Testing Specimen.

In a failure analysis research, it was necessary to test the hardness of the pulley pieces that failed, as shown in figure 6. Tests carried out using the Rockwell B hardness test equipment. The hardness test curve of the crankshaft pulley resulted from 9 hardness testing points using a load of 100 kgf.

From the data obtained through the hardness test, as shown in figure 7 the average value of the hardness of the perpendicular cross-section was 88.6 HRB. The hardness of the inner area of the pulley was lower than that of the outer area of the pulley.

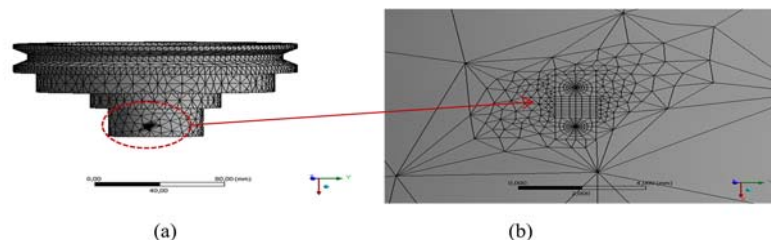
**Figure 9.** Geometry Crankshaft Pulleys after meshing.

The results of the FEA on the crankshaft pulley showed the conditions that existed when a torsion moment force of 339876.9 N.mm was exerted. The geometry of the crankshaft pulley was made using software as can be seen in figures. 9(a), and (b)). Furthermore, a crack was made on the crankshaft pulley as shown in figure 10 so that simulations could be carried out to find the stress intensity factor ( $K_I$ ) [18–20]. figure 10(a) shows the geometry of the crank axle and the given crack in the area of the groove, while figure 10(b) shows the enlargement of the crack area. The crack that was made had both a width and depth of 1 mm.

The finite element analysis to find the stress intensity factor ( $K_I$ ) near the crack tip on the crankshaft pulley by modelling the crack length and depth of 1.0 mm in the keyway area is shown in

figure 9. A stress intensity factor ( $K_I$ ) of  $88 \text{ MPa}\cdot\text{m}^{1/2}$  was obtained from the simulation results larger than the fracture toughness ( $K_{IC}$ ) of the material was about  $41 \text{ MPa}\cdot\text{m}^{1/2}$  (as shown in table 2) . Therefore, this result indicated that crack propagation occurred on the crankshaft pulleys until final failure.
