Wear's issues on high-pressure common rail pumps

R C Iordache, N D Petrea and C Bujoreanu

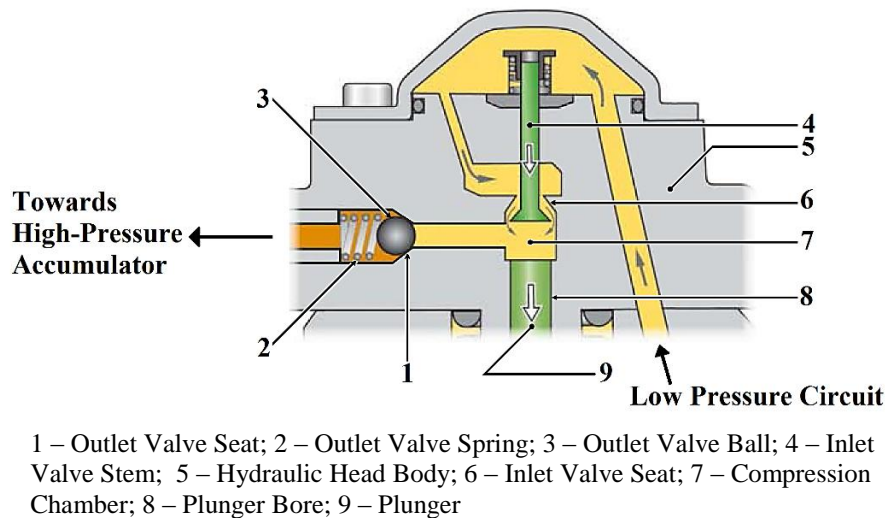
The inlet valve with the outlet valve and the plunger assembled on the hydraulic head body, together form the hydraulic head assembly of the common-rail pump (figure 7). The hydraulic head is one of the most stressed parts of the pump, its role being to compress the fuel at pressures of over 2000 bar.

Figure 7. Hydraulic head assembly with valves and plunger [6].
